DATE: April 13, 2023

FROM: John Gibson, Chief Plant Operator

SUBJECT: OPERATION REPORT: March, 2023

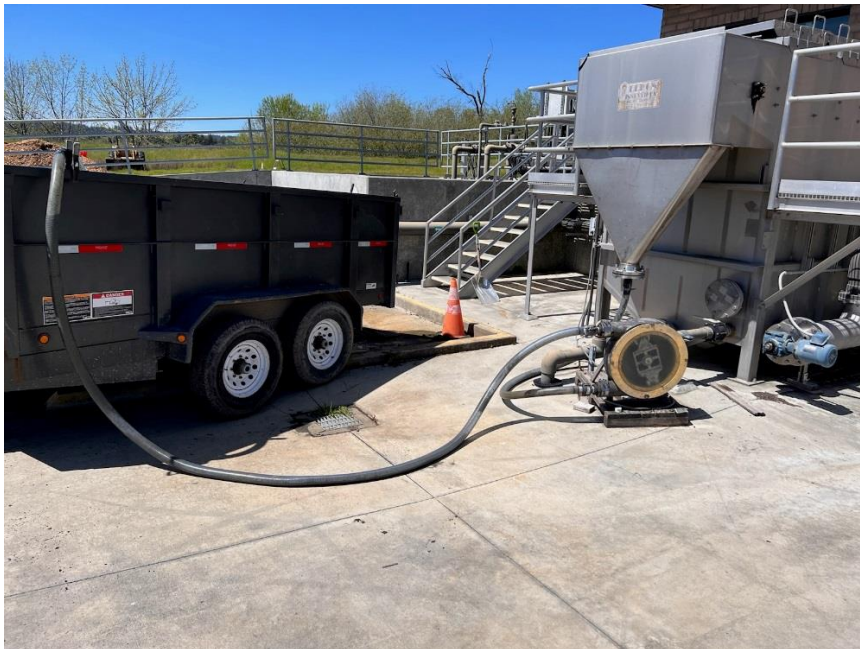
The Vector peristaltic pump moves the skimmed solids from the SAF hopper to the dewatering trailer. During operation the machine screws that connect the mounting brackets to the shaft that supports the rollers cracked allowing the rollers to move and not compress the peristaltic hose enough to pump the sludge. The rollers were removed and rebuilt at Sebastopol Bearing. The solids were routed back to the settling pond during treatment operations and diluted with recycled water. The rebuilt rollers have been reinstalled and the sludge pump is back online. Additional spare rollers have been ordered and are pending arrival. The influent and effluent hoses to the sludge pump were replaced, the inner peristaltic tubing flipped to extend the life of the hose, and additional silicone lubricant applied the surface area of the hose and rollers.

Sludge pump in operation
