TECHNICAL MEMORANDUM

DATE: March 12, 2024 Project No.: 1088-60-23-02

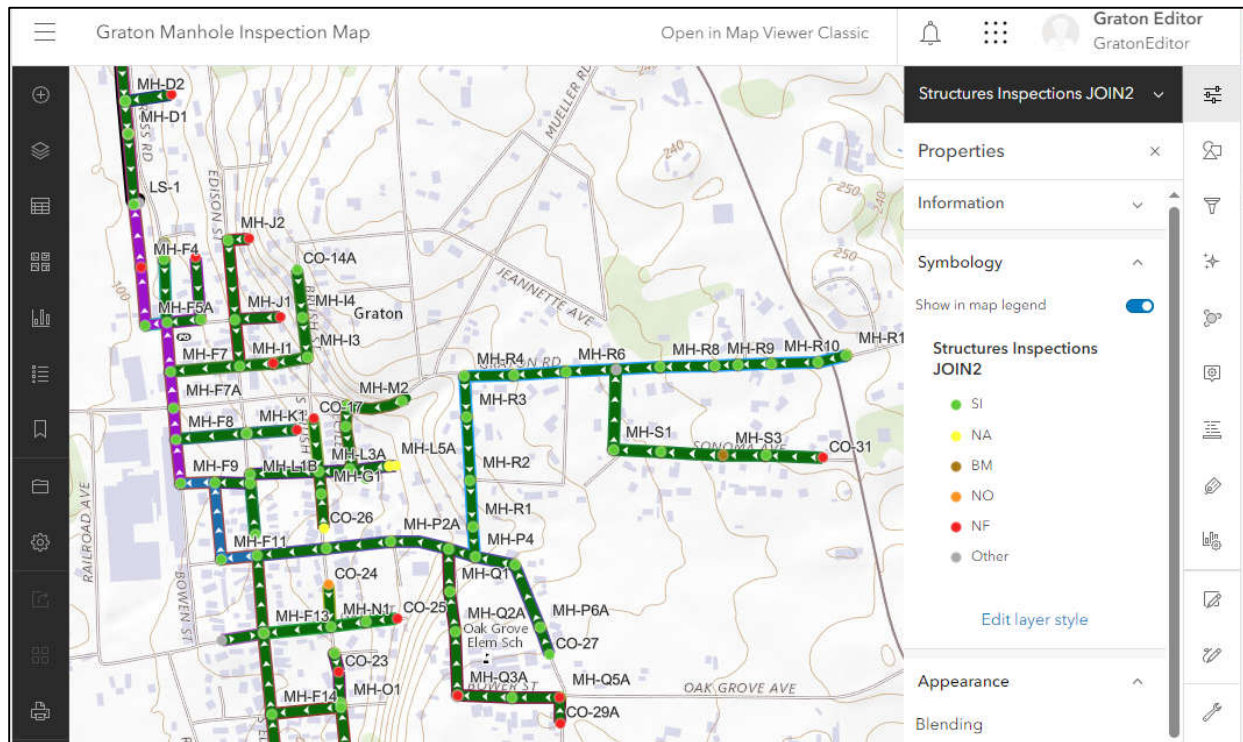
Figure 2. Graton CSD ArcGIS Online Map

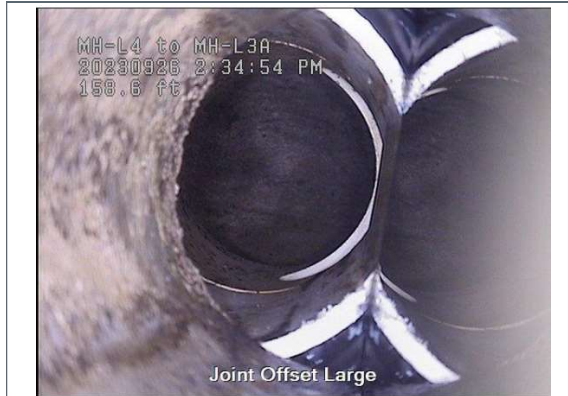
Photo 1.
Offset Joint - Large (camera rotated 90° clockwise)

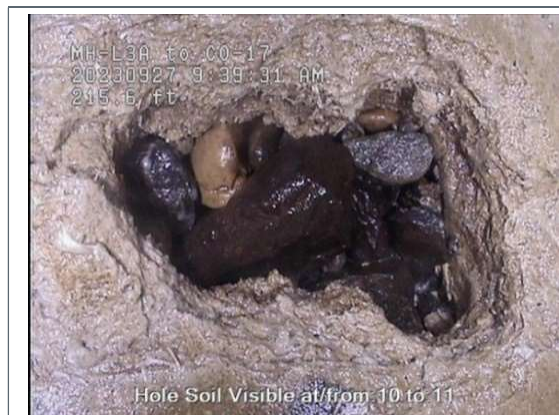
Photo 3.
Hole/Broken with Voids Visible

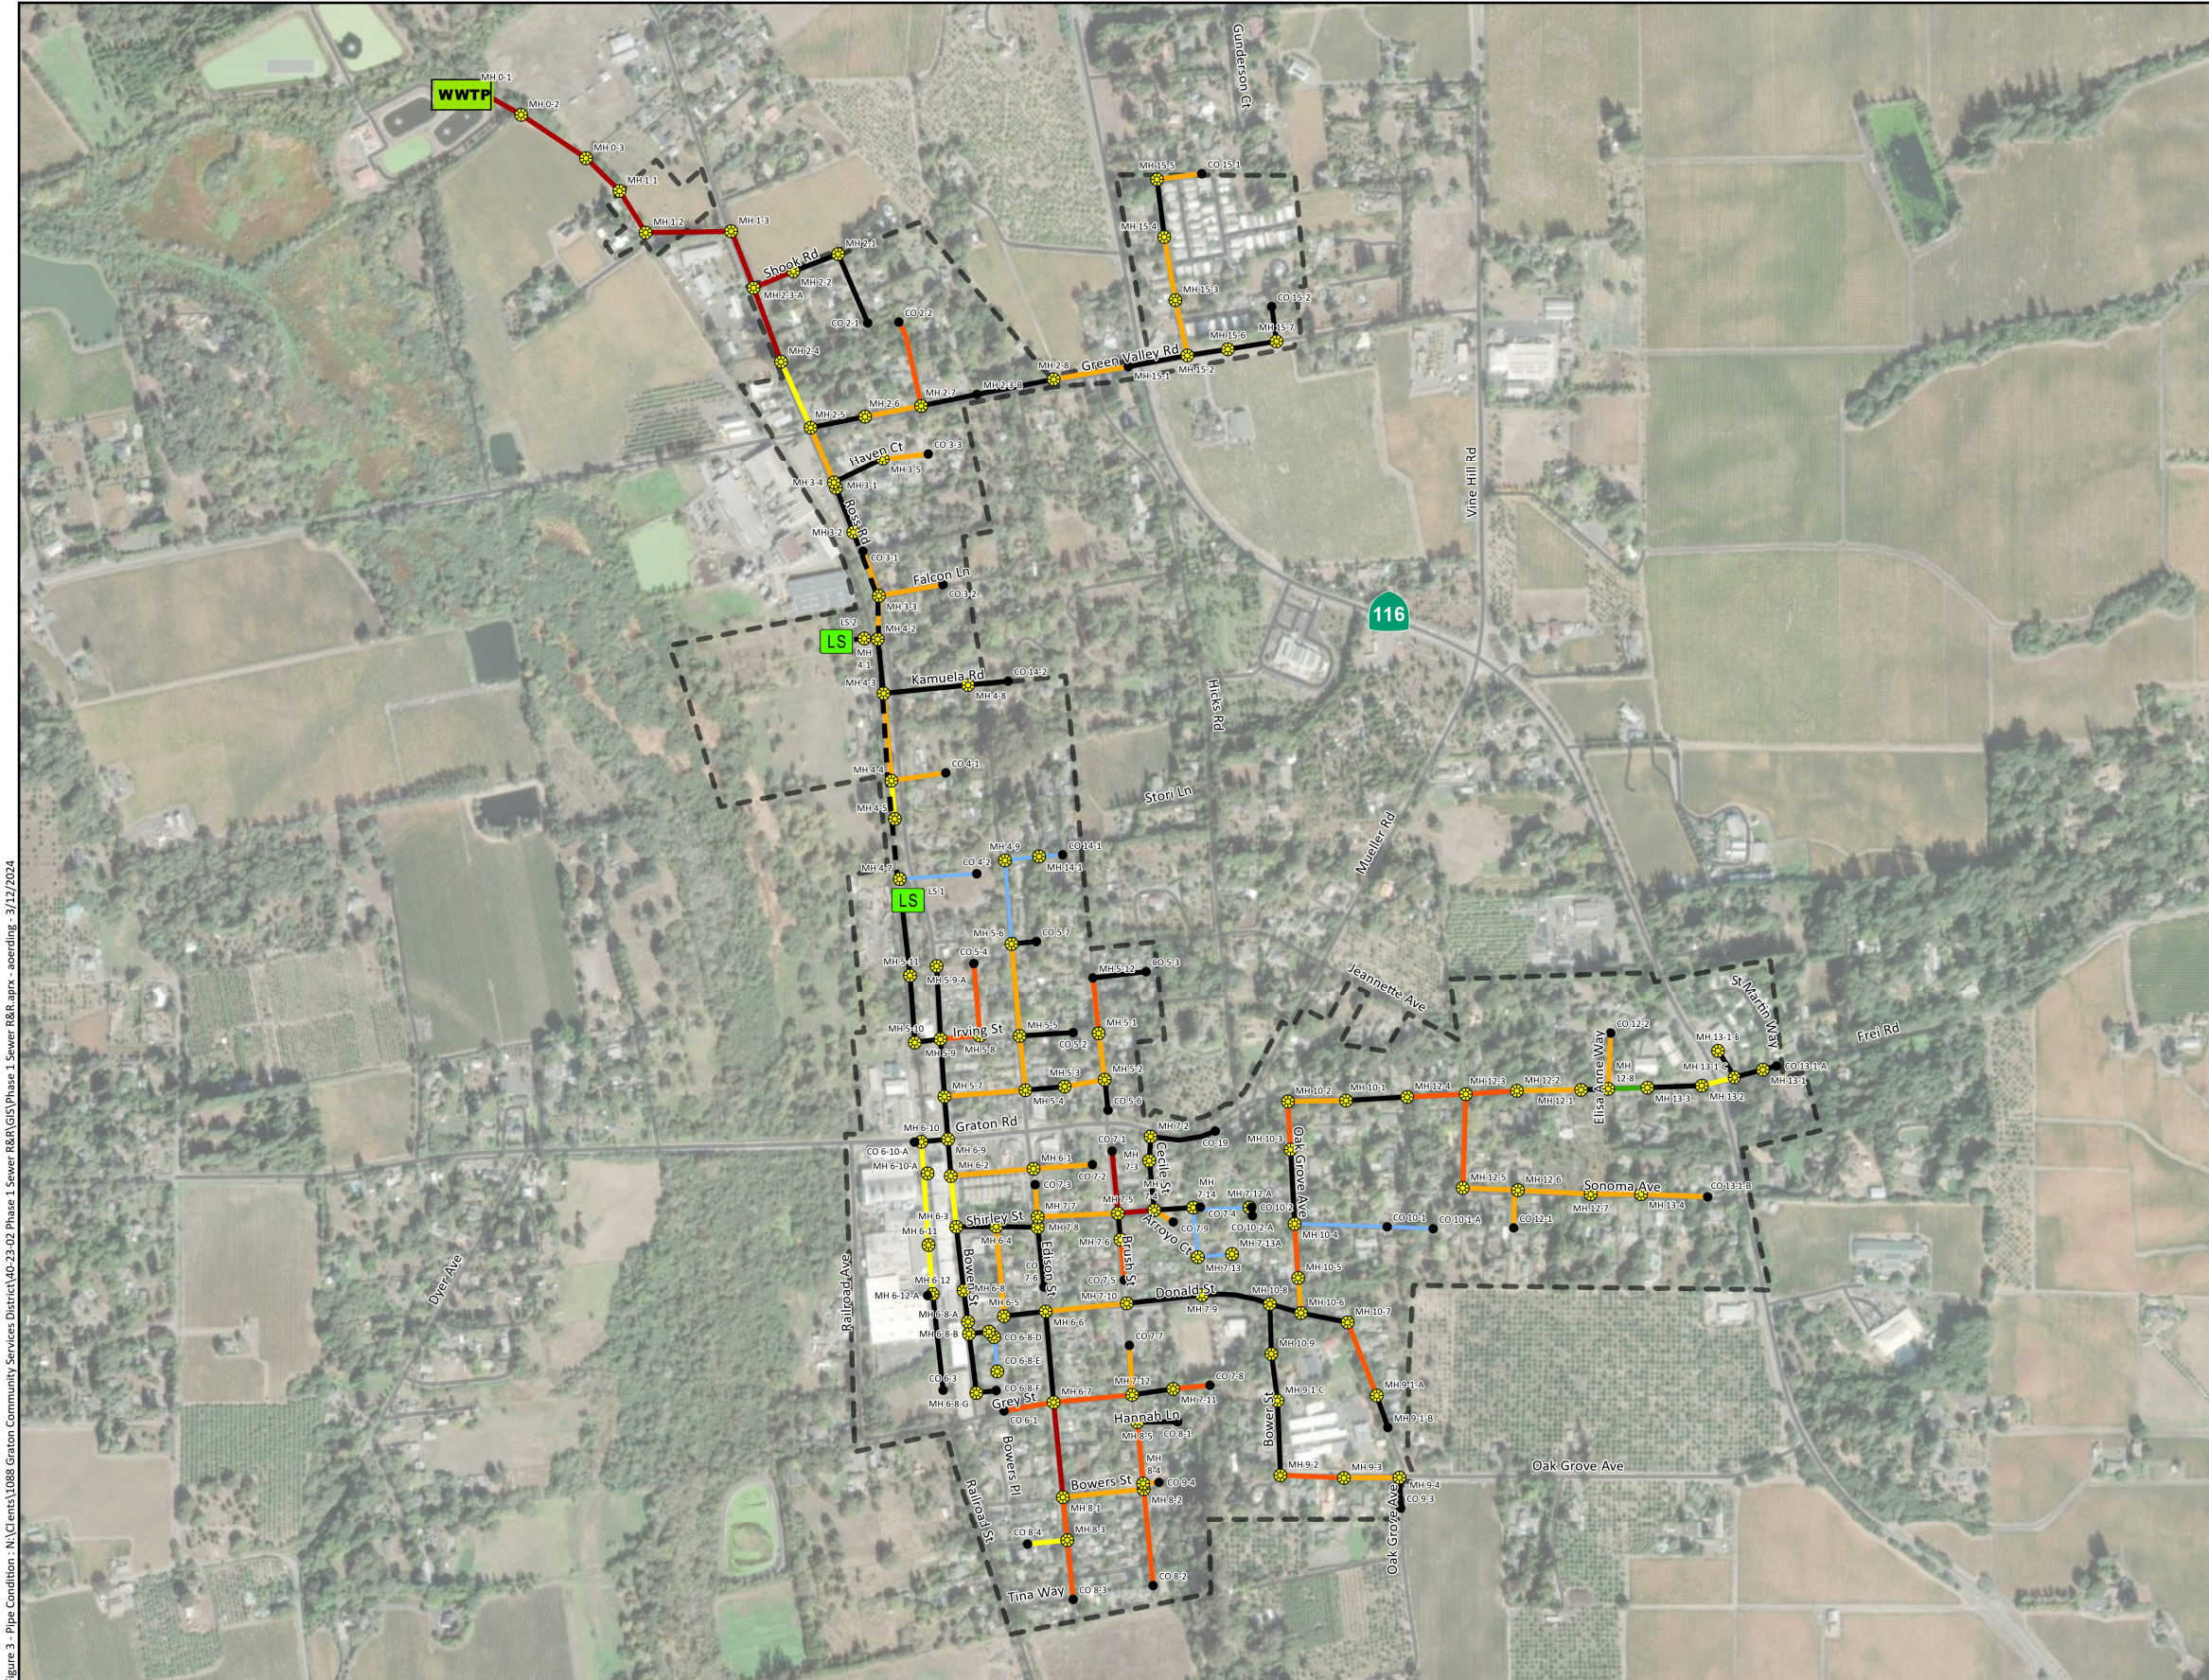
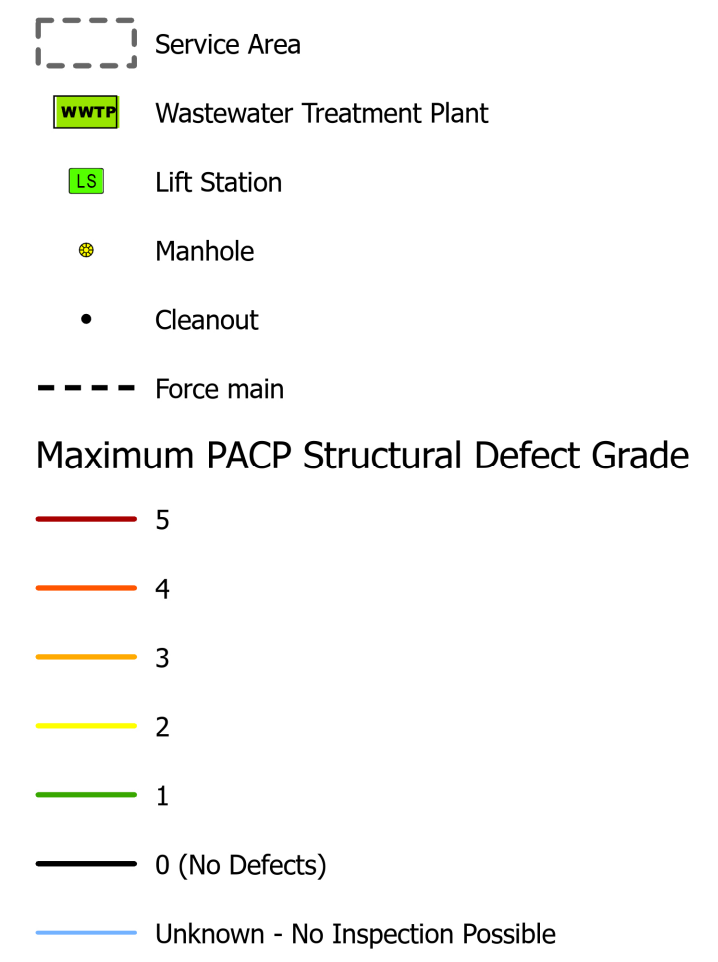
Figure 3 - Pipe Condition - N:\Clients\1088 Graton Community Services District\40-23-02-Phase 1 Sewer R&R\GIS\Phase 1 Sewer R&R.aprx - as of 3/12/2024

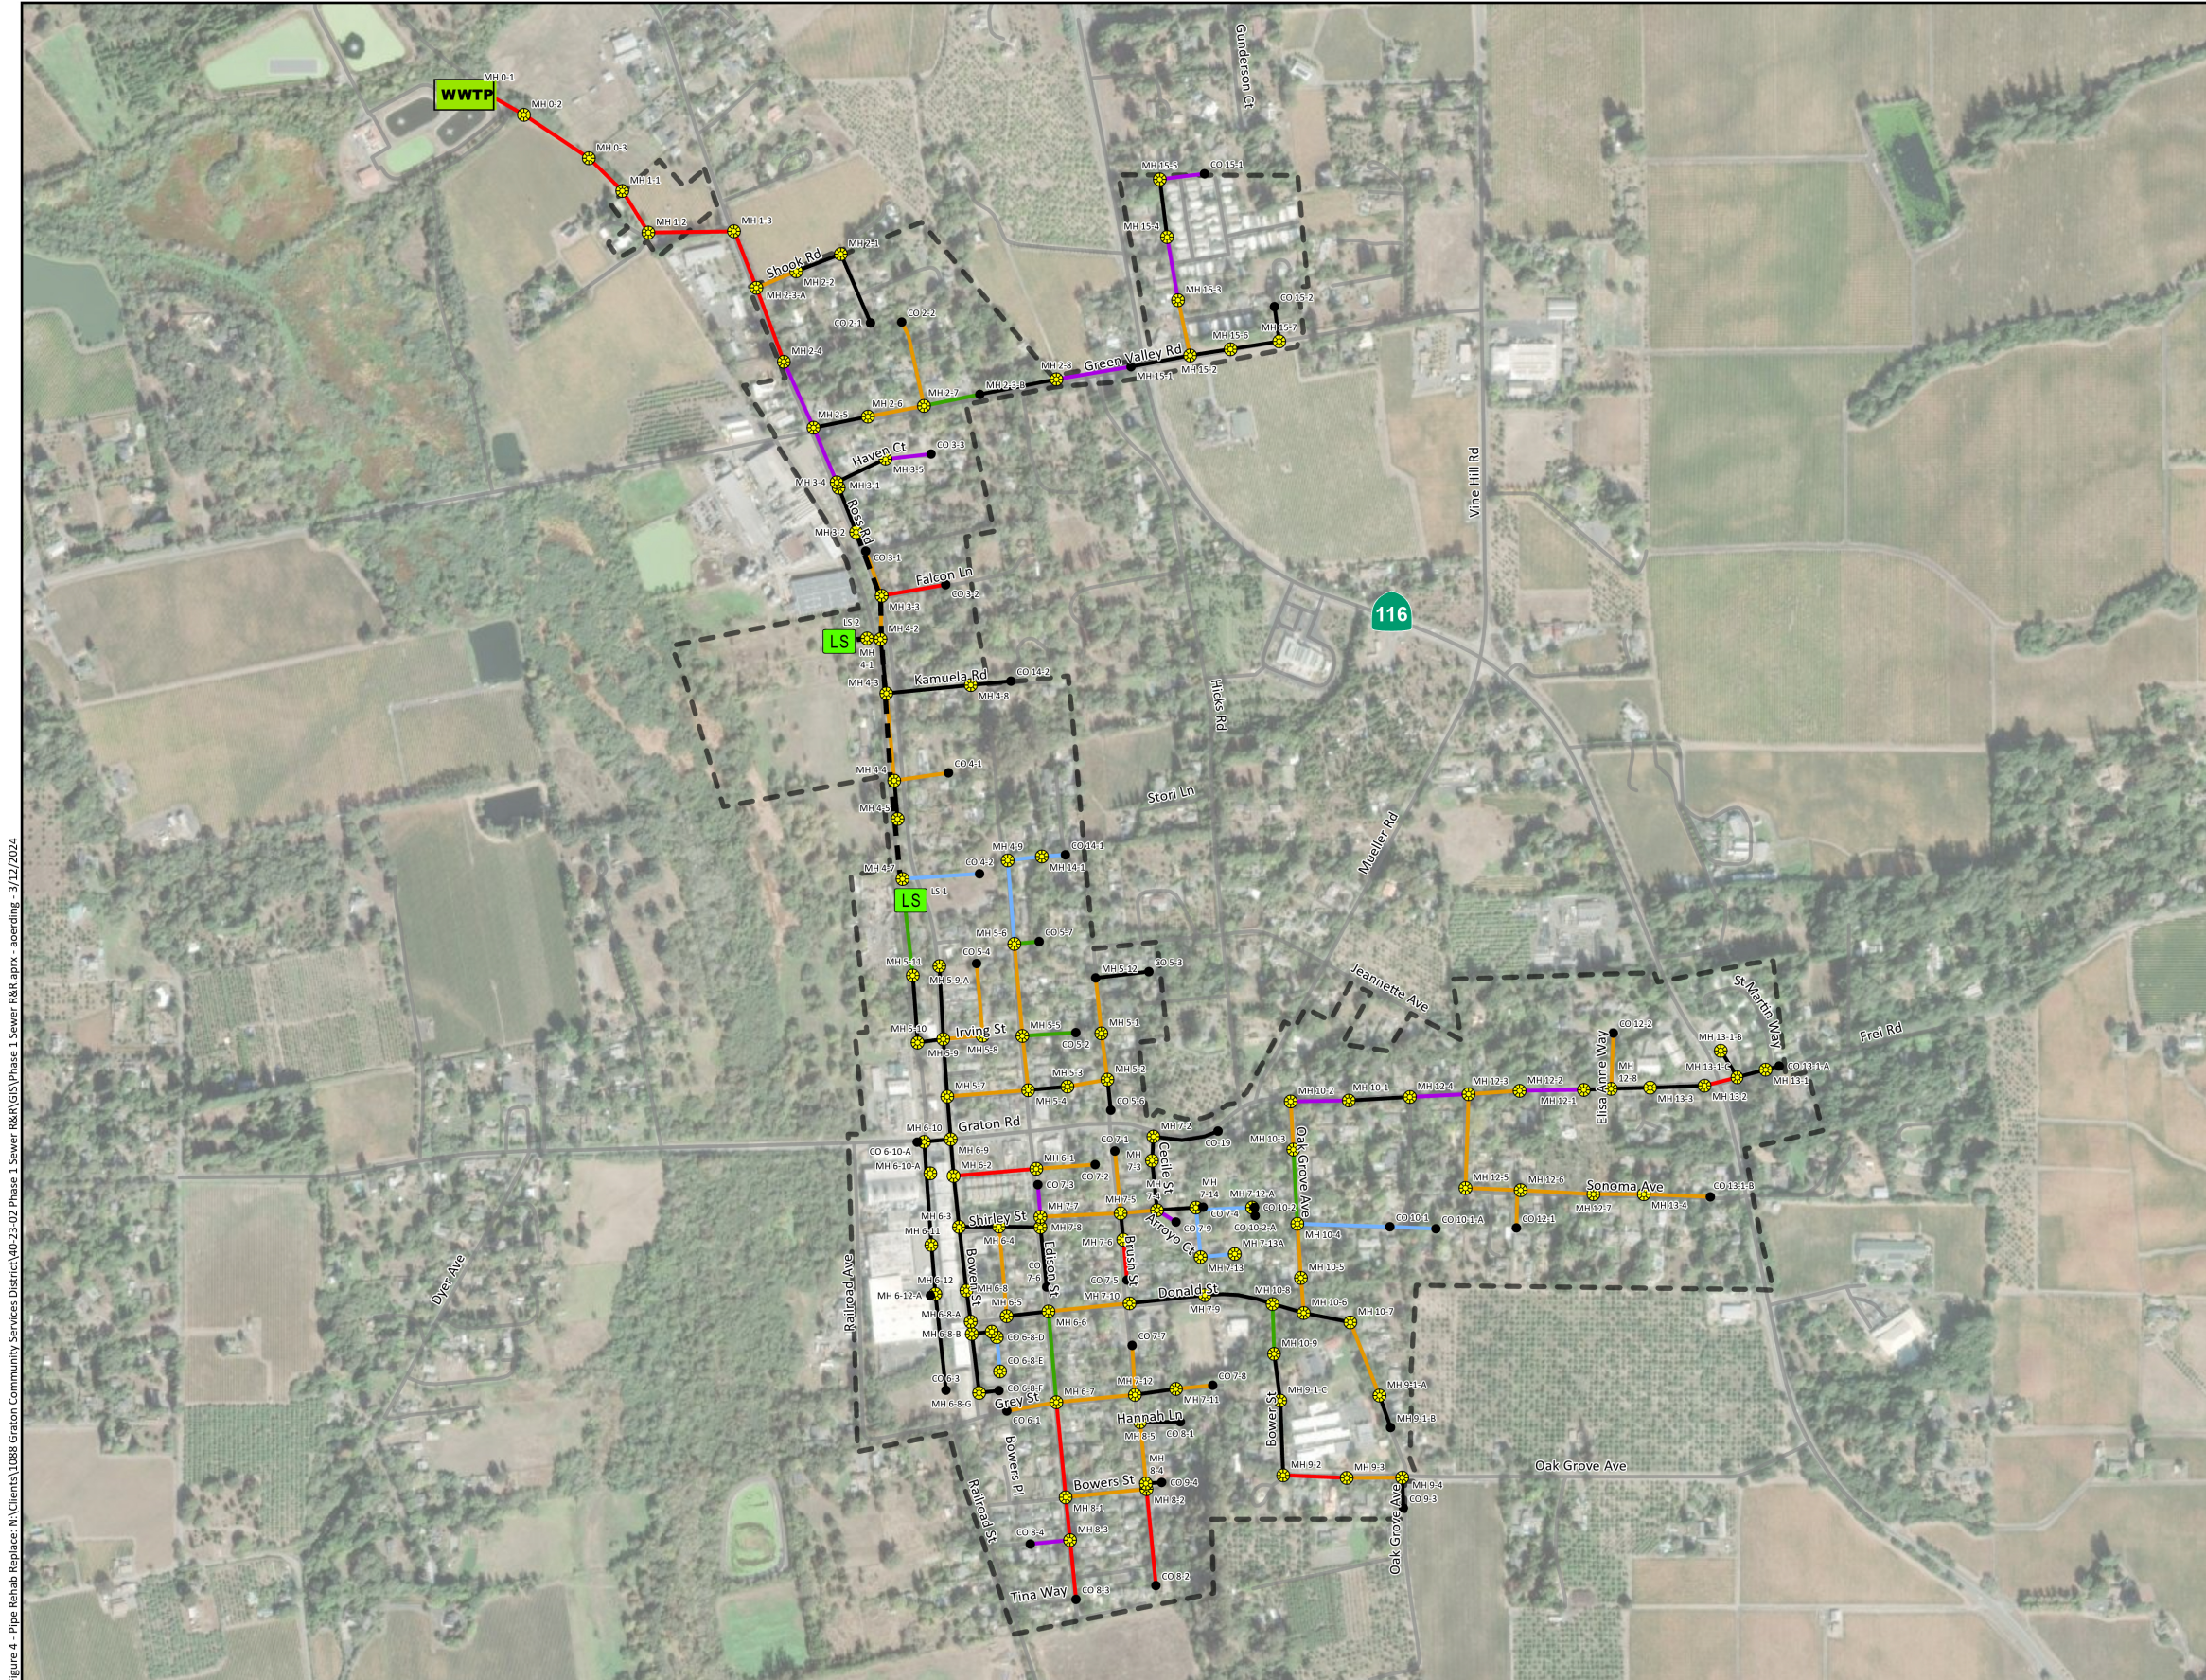
- WWTPl Wastewater Treatment Plant
 - LS Lift Station
 - Manhole
 - Cleanout
 - Force main
- ### Pipeline R&R Recommendations
- No R&R Required
 - Maintenance Only
 - Spot Repair
 - CIPP
 - Full Replacement
 - Unknown - No Inspection Possible

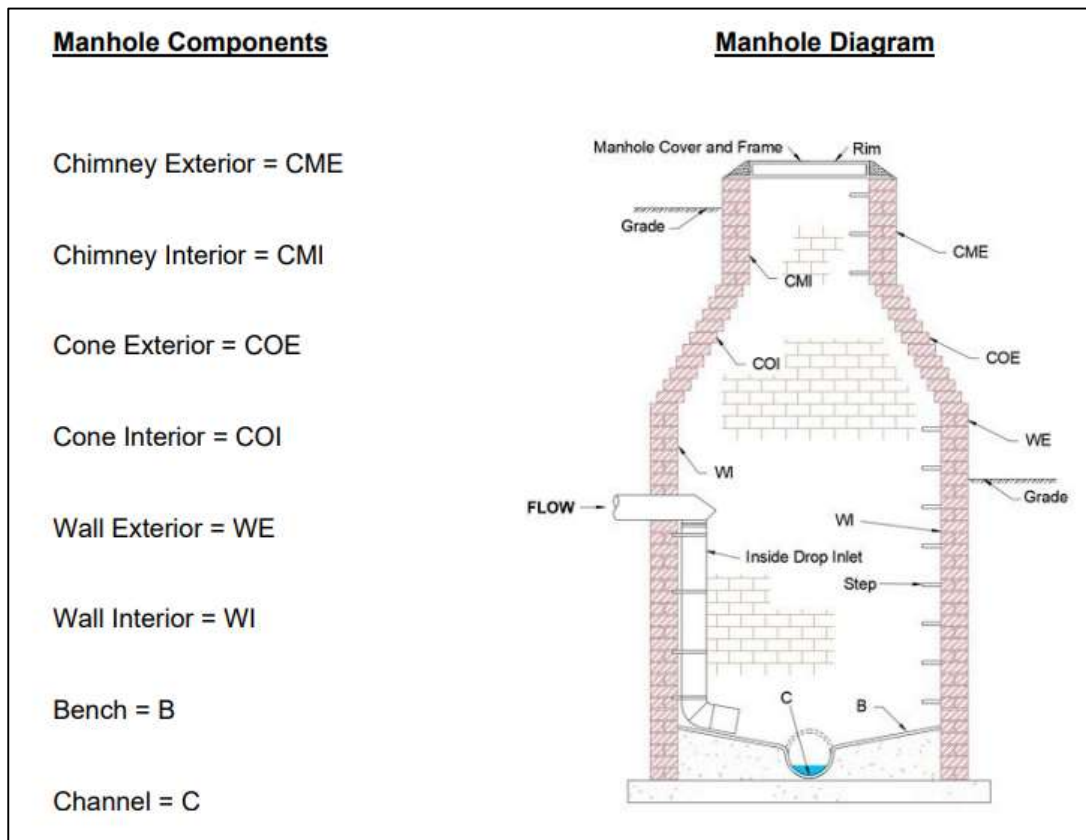
Figure 5. Manhole Component Diagram

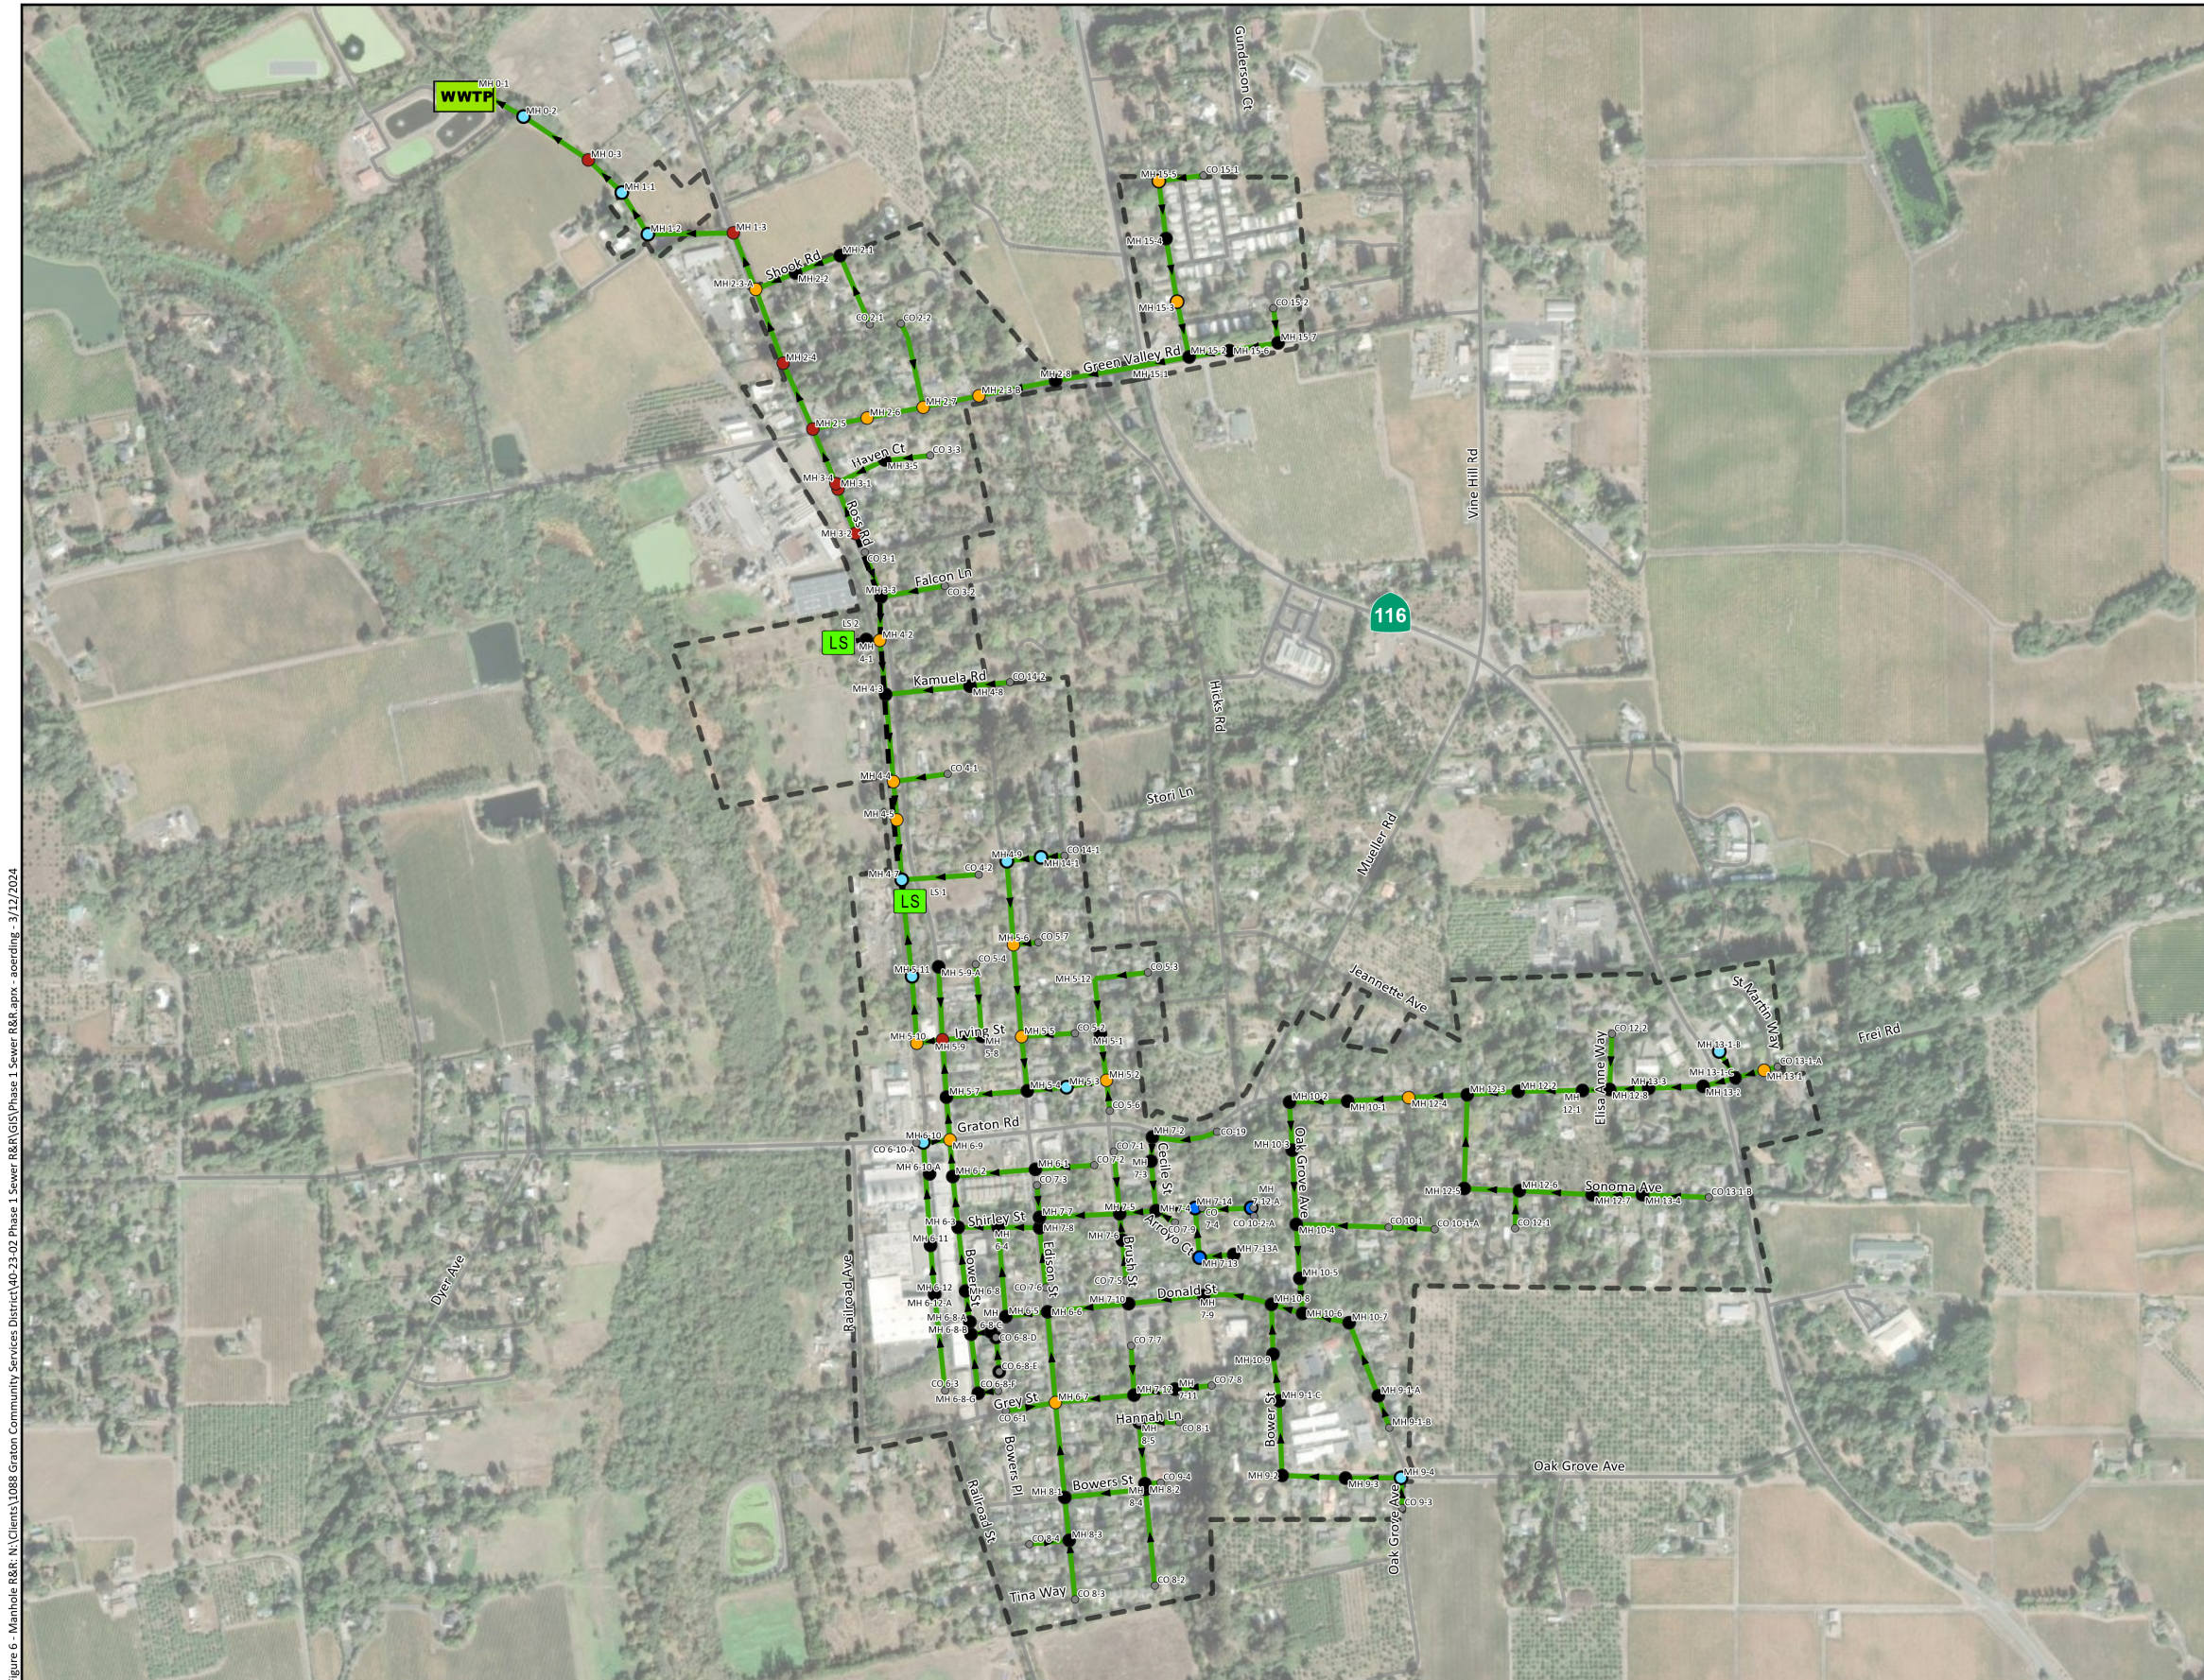
- WWTP Wastewater Treatment Plant
- LS Lift Station
- Gravity Main
- Force Main

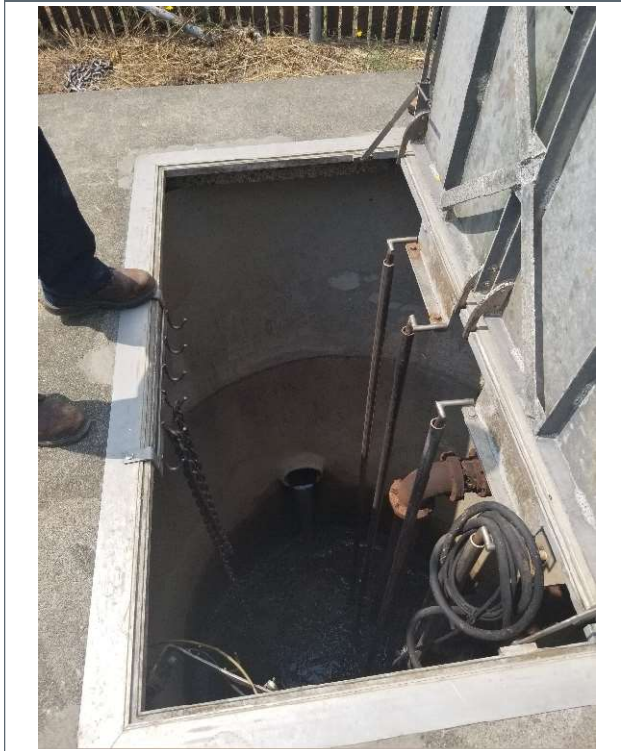
Photo 4.
Lift Station 1 Wet Well

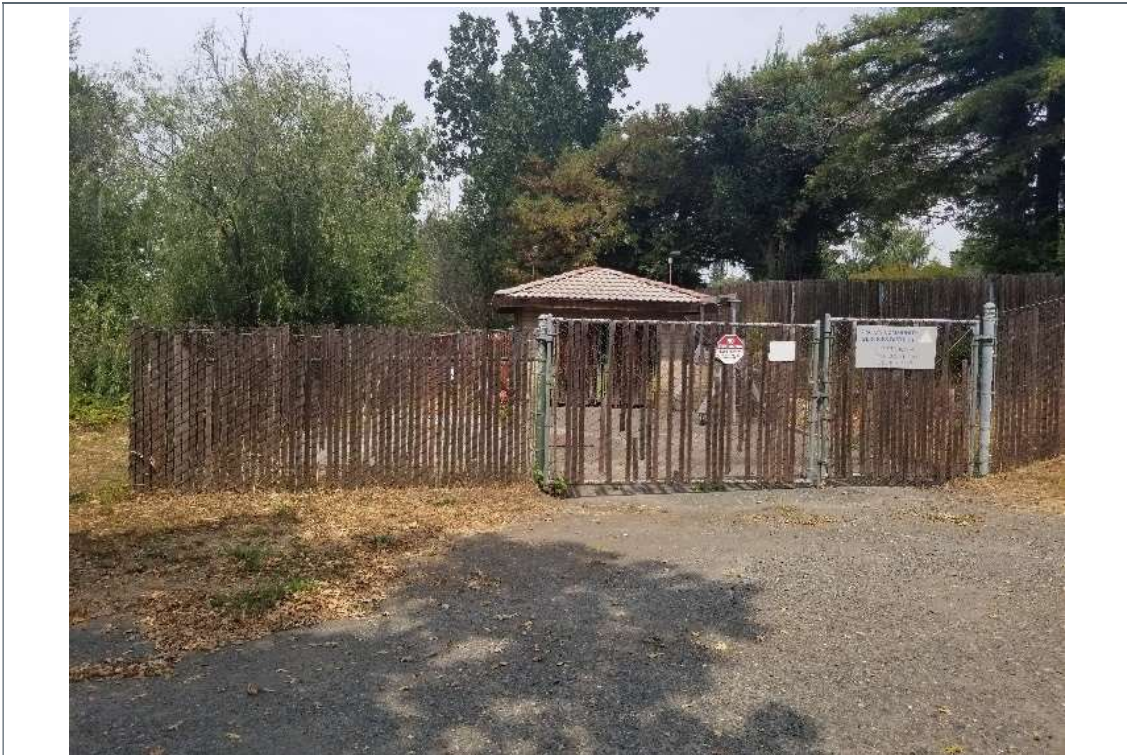
Photo 6.
Lift Station 1 Site

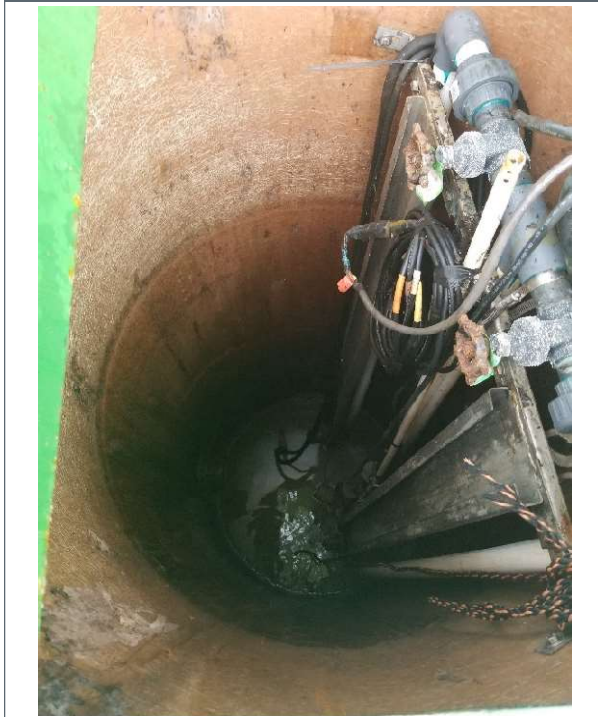
Photo 7.
Lift Station 2 Wet Well
