DATE: December 15th, 2022

FROM: John Gibson, Chief Plant Operator

SUBJECT: OPERATION REPORT, November 15th – December 15th 2022

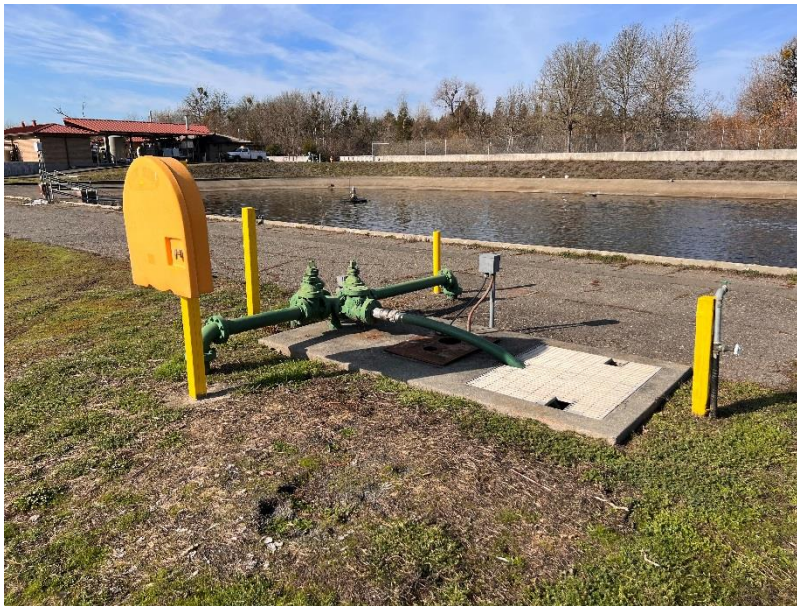
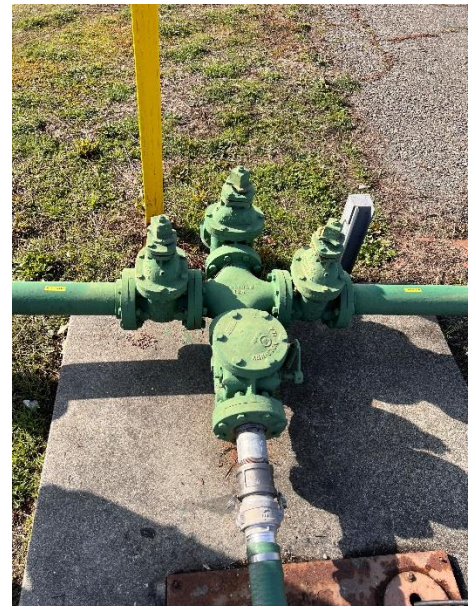
Control Vault Structure #1 (CVS#1)

- Repainted bollards and posts around CVS#1.
- Removed rotted out 4x4 post holding up the emergency life preserver enclosure and installed a new post. Power washed the enclosure and inspected the life ring and rope condition.
- Replaced the CVS#1 recirculation pump.
- Replaced cracked PVC fittings with a black iron threaded coupler and replaced the 3" camlock gasket.
- Labeled piping and flow direction.

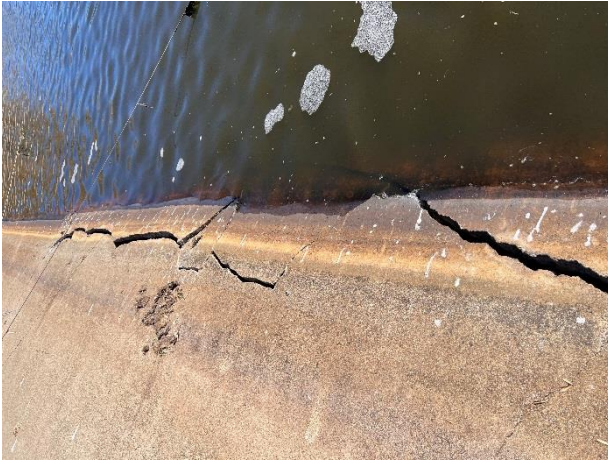
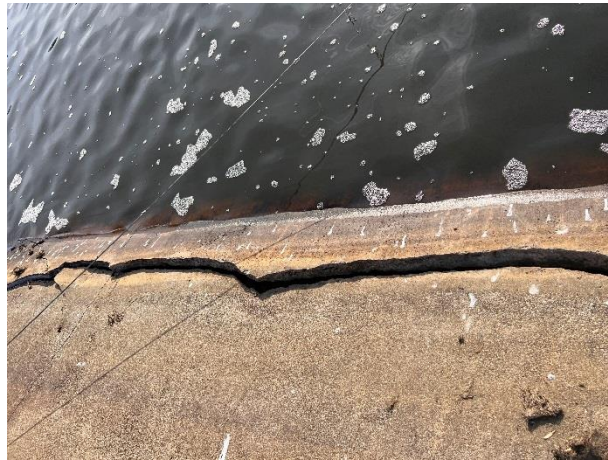
Photos of the cracks around Pond 2

The concrete skirt around treatment pond #2 recently cracked and separated on the NW side to a distance just under 35' in length. (see photos below) The NCRWQCB has been notified of the damage and temporary repairs that have been made until a professional assessment can be performed. We are unsure what caused these enlarged cracks and movement of the concrete at pond 2. We did receive callouts for equipment power failures around the plant on that Sunday, which was the day before we discovered the large cracks. We have not been able to ascertain what could have caused the damage to the pond as well as create power failure alarms on multiple pieces of equipment. Due to their age and method of

construction both Pond 1 and Pond 2 have small cracks around the concrete skirts and are in similar condition. Operators routinely repair both ponds using a concrete crack filler to fill and seal any noticeable cracks around the concrete skirts.

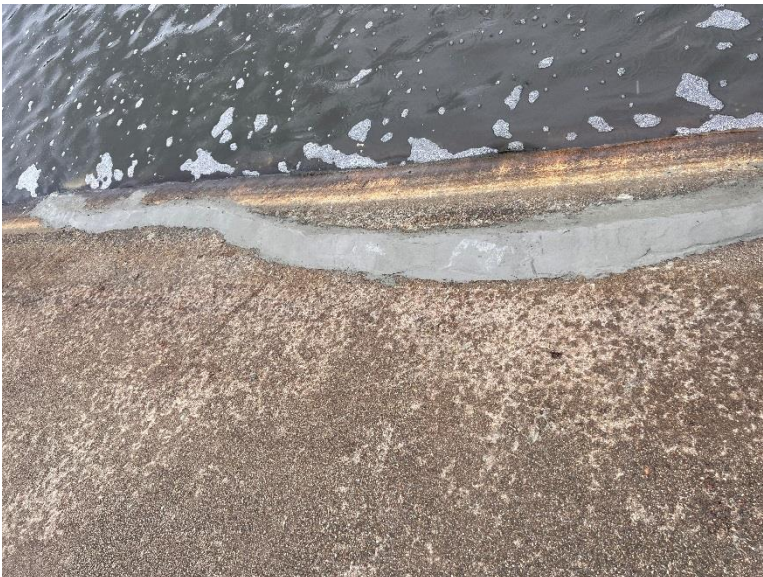
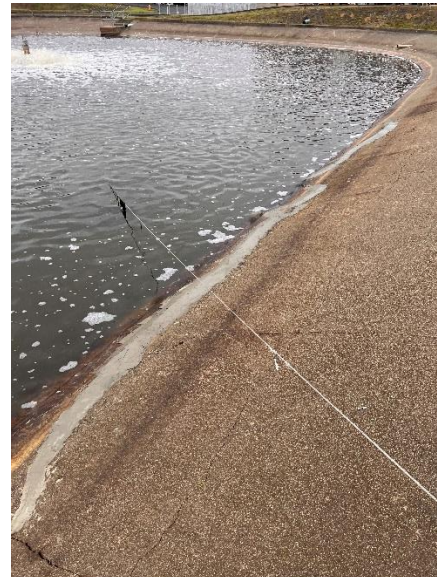
After temporary repairs have been made
